HELP FROM ABOVE

Dommages au bâti,
évaluation par quartier

Damaged building density
Situation the 13th of January 2010

Damaged building density
and gathering areas

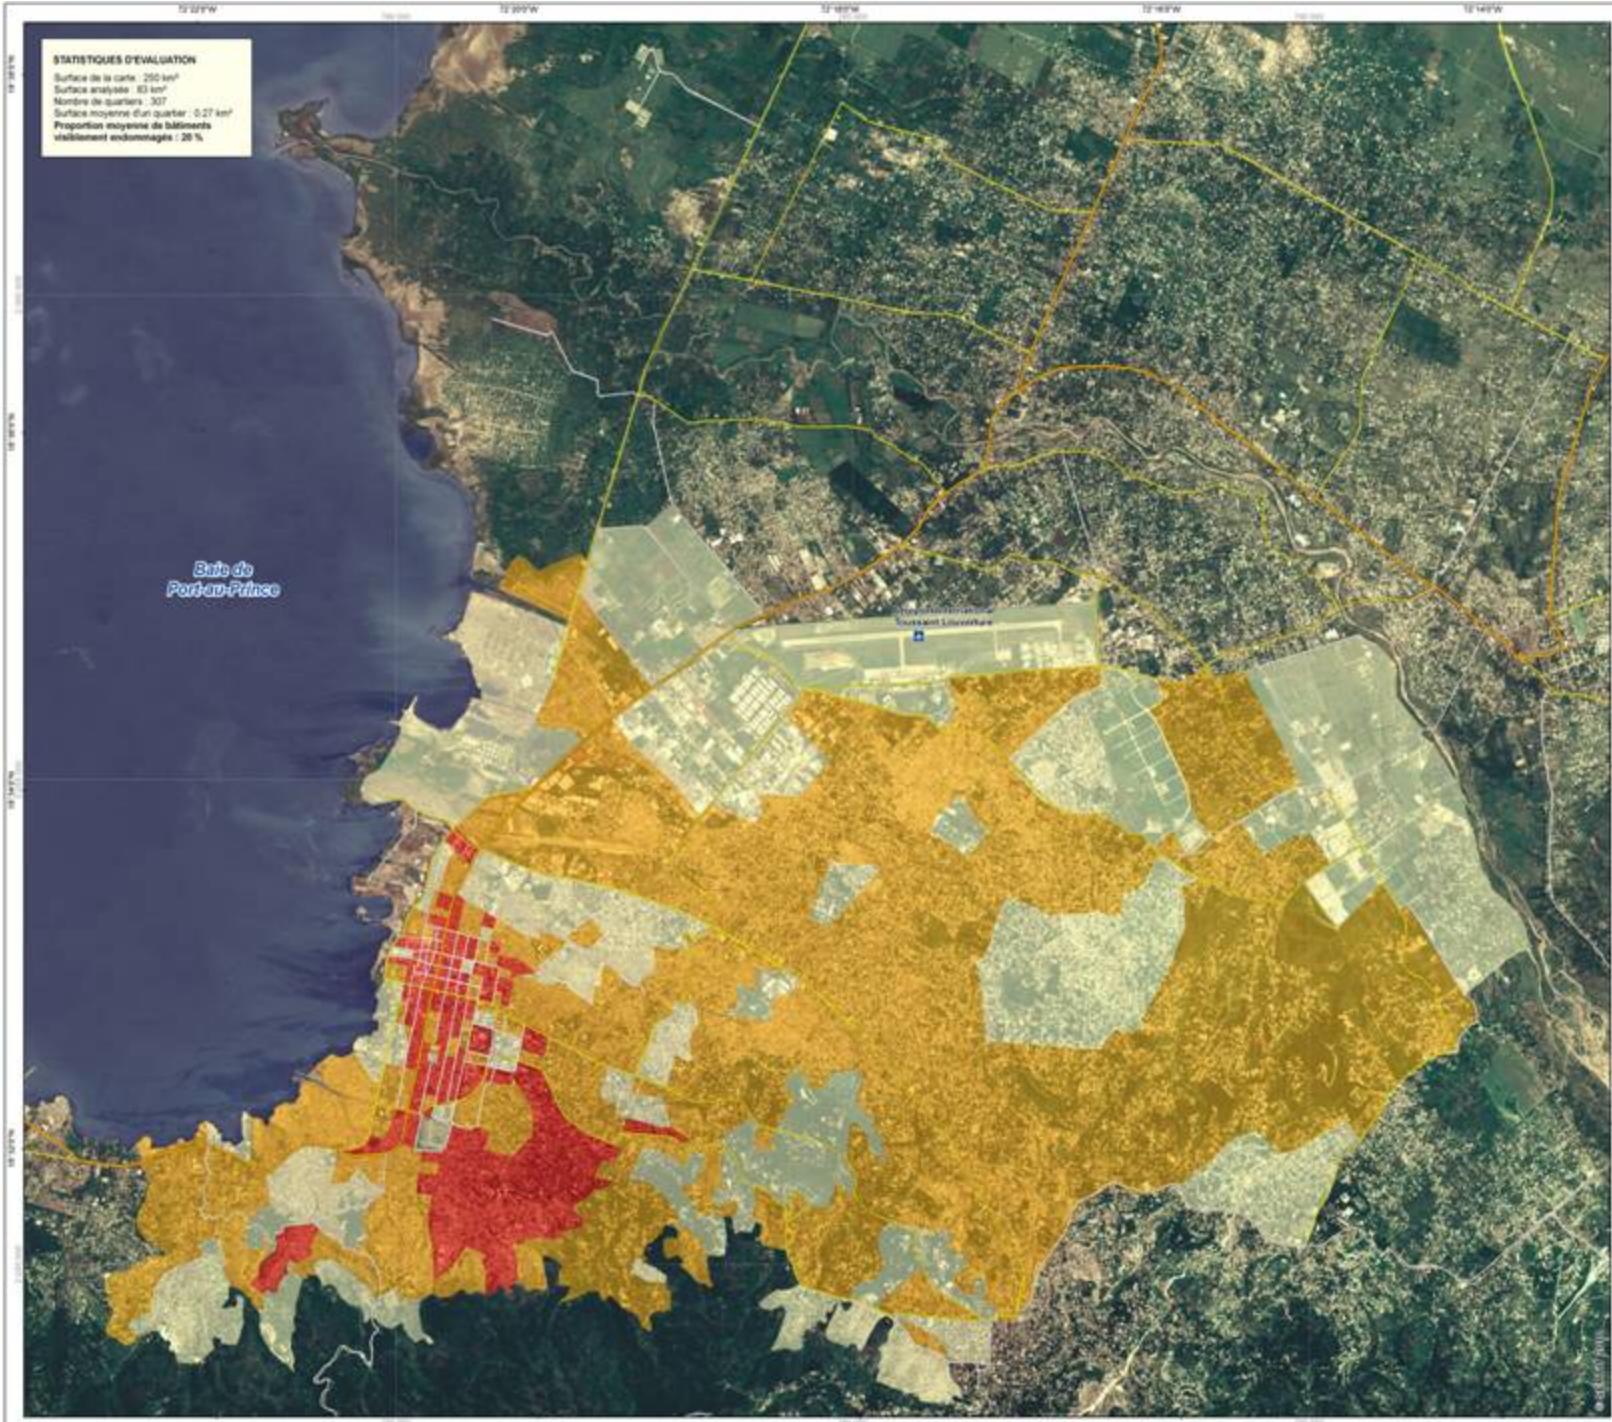
Pour chaque quartier, le pourcentage exprime une évaluation de la proportion de bâtiments avec des dommages observés.

Le 12 janvier 2010 à 21h53 (GMT), 16h53 (locale), un violent séisme de magnitude 7 sur l'échelle de Richter a secoué Haïti. Cette carte illustre une première évaluation des dommages dans l'agglomération de Port-au-Prince fondée sur l'exploitation d'images satellites.

Cette appréciation des dommages est réalisée sur la base d'une observation de la proportion de bâtiments présentant des dégâts observables. Cette première estimation doit être utilisée avec précaution, elle sera précisée dans les jours à venir.

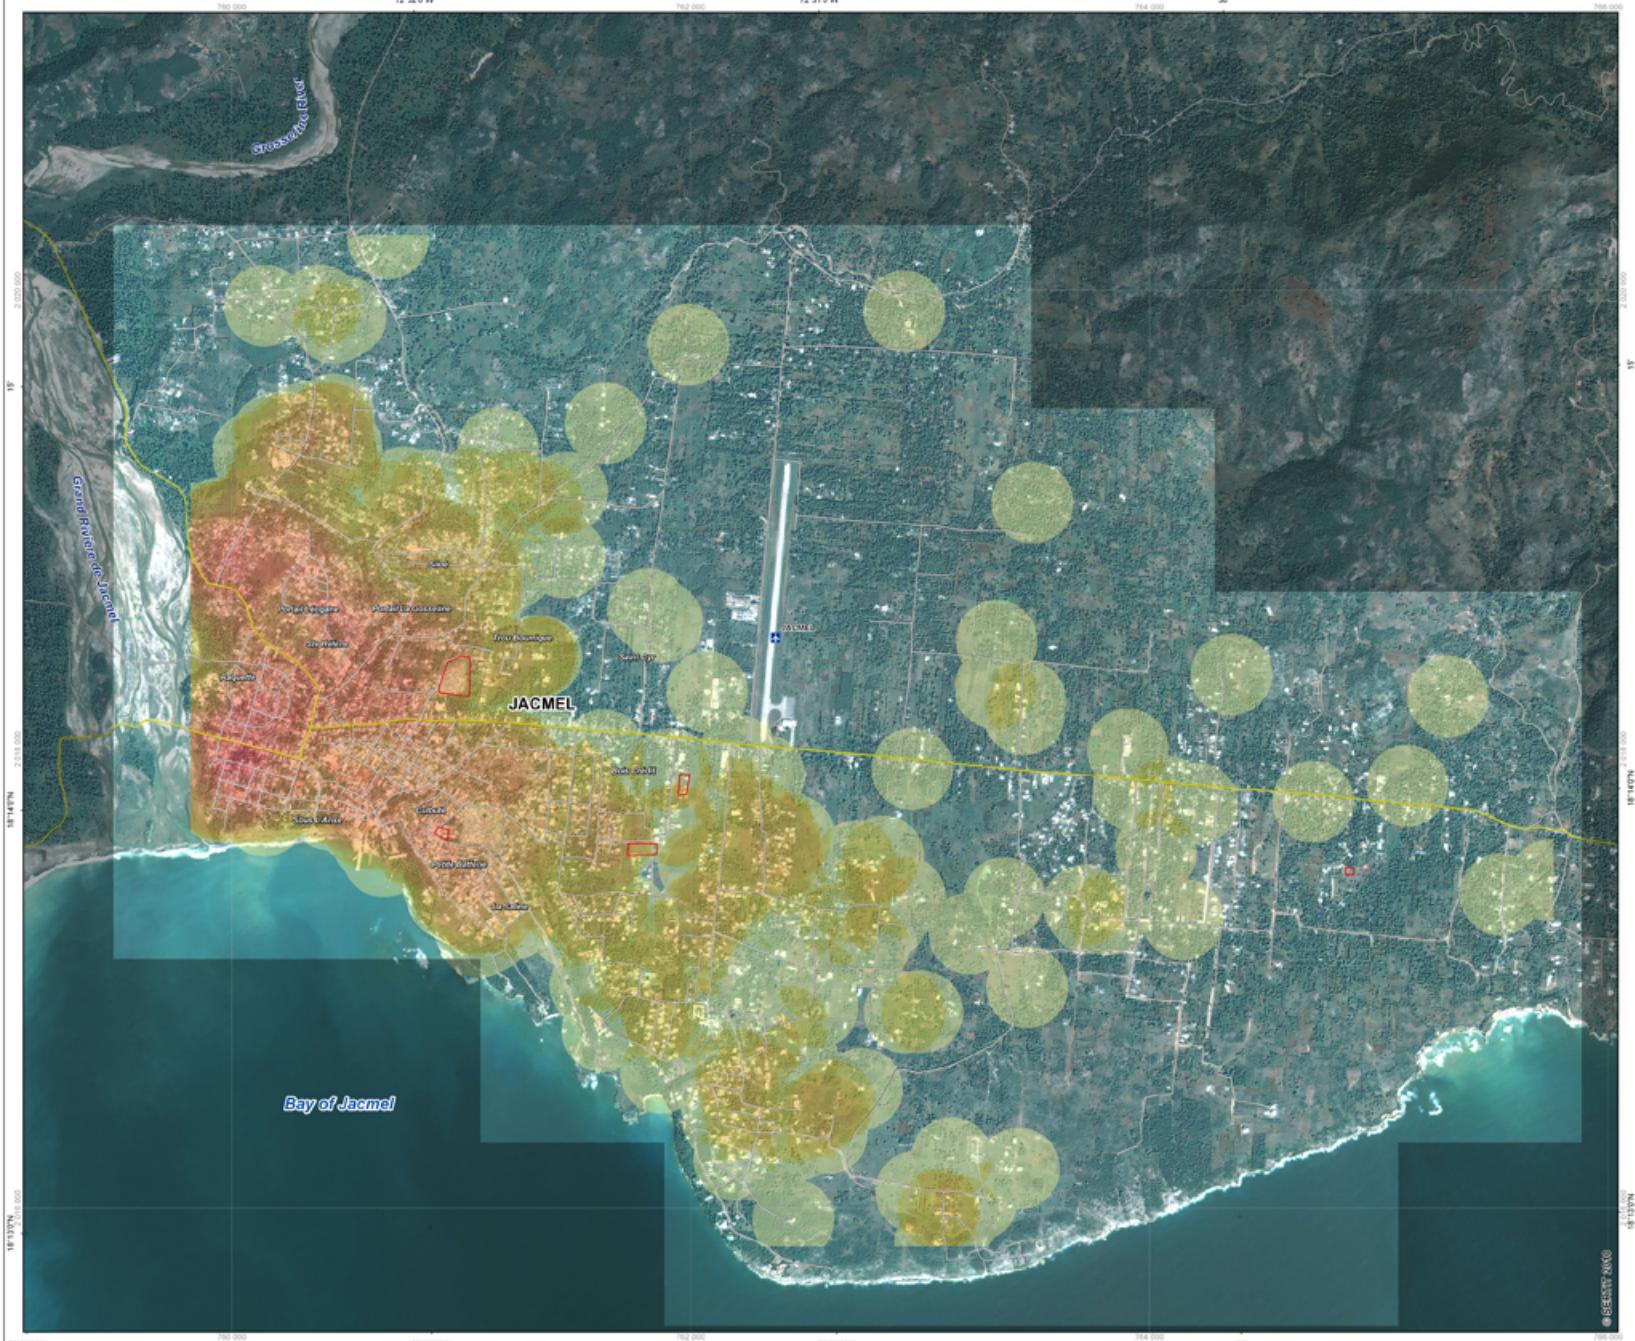
Situation the 15th of January 2010

A strong earthquake of magnitude 7.0 hit Haiti on the 12th of January 2010 at 21h53 (GTM). 16h53 (local time). The epicenter was located 15 km West of the city of Les Cayes. Principally buildings and infrastructure damages are recorded and reported. This map shows a density of damaged buildings and gathering areas as observed in DigitalGlobe imagery acquired the 15th of January 2010 in the city of Jacmel. The surface of the country circle is 0.1 square kilometers. In a 21 km² analysed area. The results shown in this map should be used with precaution. Extensivity is not guaranteed.
